Impact Analysis of the Whirlwind Disaster on Residential Roof Frame Structures (Case Study in Tonro Kassi)

ABSTRACT: *Damage to buildings due to wind disasters is often found on the roof truss of a building. Thus, roof truss structure is an important part of construction. This study aimed to determine the damage to the roof truss structure due to the wind disaster in Tonrokassi village, Tamalatea district, Jeneponto Regency, the vulnerability of the building and identify the existing roof truss after the disaster. The method of classifying damage levels of structures is by using the Fujita scale. Based on the field scoring results, it can be seen that the damage is almost entirely on the roof. For the level of damage for point 1, it is only damage to the roof such as zinc being released from the frame. While the house has a damage level of 2, the roof has been damaged and part of the roof frame has been blown off.*

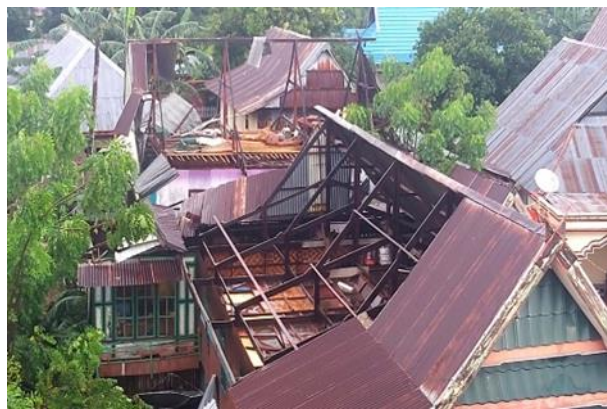
Based on the results of the scoring in the field, it can be seen that the damage occurred almost entirely in the roof. As for the level of damage with a score of 1, there is damage to the roof covering only such as zinc being detached from the frame. While the house with a damage level score of 2, experienced damage to the roof covering and part of the roof frame was detached.

The roof damage that occurs is due to the nature of the wind which sucks and sometimes grabs objects in front of it, so that the most dominant part of the roof is damaged as shown in Figure 2.

Fig 2. Sample of roof damage

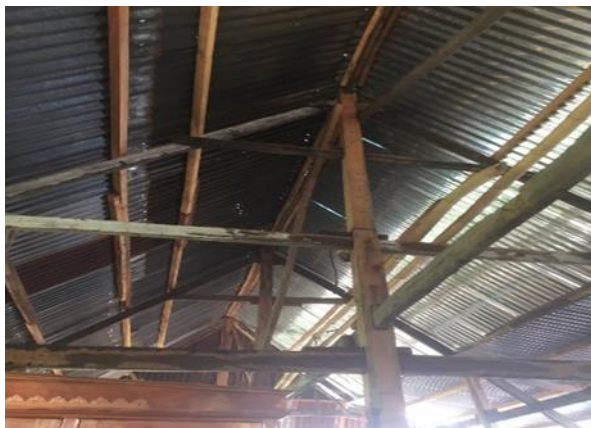
Fig 4. Roof truss seen from inside the house

The existing roof truss uses a conventional truss structure as shown in Figure 4 with beams measuring 4 x 11 cm. The span of the trusses is 6 m with a maximum distance between the trusses of 3 m. The curtain rod is 6x6cm and the curtain rod is 3x4cm. While the roof covering is zinc material.

Meanwhile, for earthquake-resistant timber frame house design, the joints must be fixed with nails at least 2.5 times the thickness of the smallest wood, with at least 4 (four) pieces. If the wooden structure is subjected to high stress, wooden joints should be secured with dowels of at least 10 mm [14].
