# Health Assessment of Old Tailing Dam- A Case Study

The growth of the mining industry, mainly driven by increased resource demands, has accelerated the production and storage of mine waste. Tailings comprise the fine-grained fraction of this waste. Due to their intrinsically hazardous characteristics from a geochemical and geotechnical perspective, tailings are conventionally discharged in slurry form behind constructed dams for public and environmental safety purposes. However, tailings dams have been under significant scrutiny following a number of high-profile, catastrophic breach events in, for example, Jagersfontein, South Africa (2022), Corrego do Feijao, Brazil (2019), 2019 Hindalco Muri failure (Jharkhand) releasing red mud, and the 2022 Thelkolo breach (Odisha) from a JSW Bhushan Power slurry pond etc. Insufficient understanding of geotechnical properties of waste material (tailing), faulty construction method, heavy rainfall, seismic activity etc. are major cause of failure of tailing dam. This paper presents the results of Health assessment (geotechnical site investigation) in one of the old tailings storage facilities (copper tailing) located in the North Central part

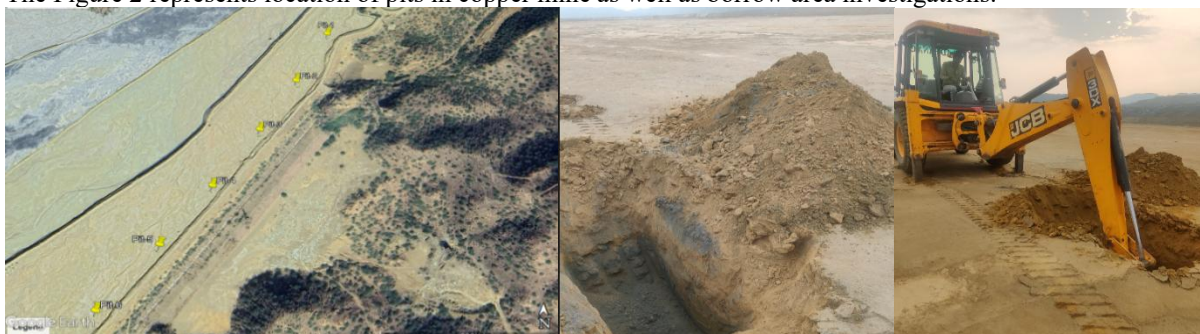
Figure 2: Location of pits in copper mine as well as borrow area investigations

The Figure 2 represents location of pits in copper mine as well as borrow area investigations:

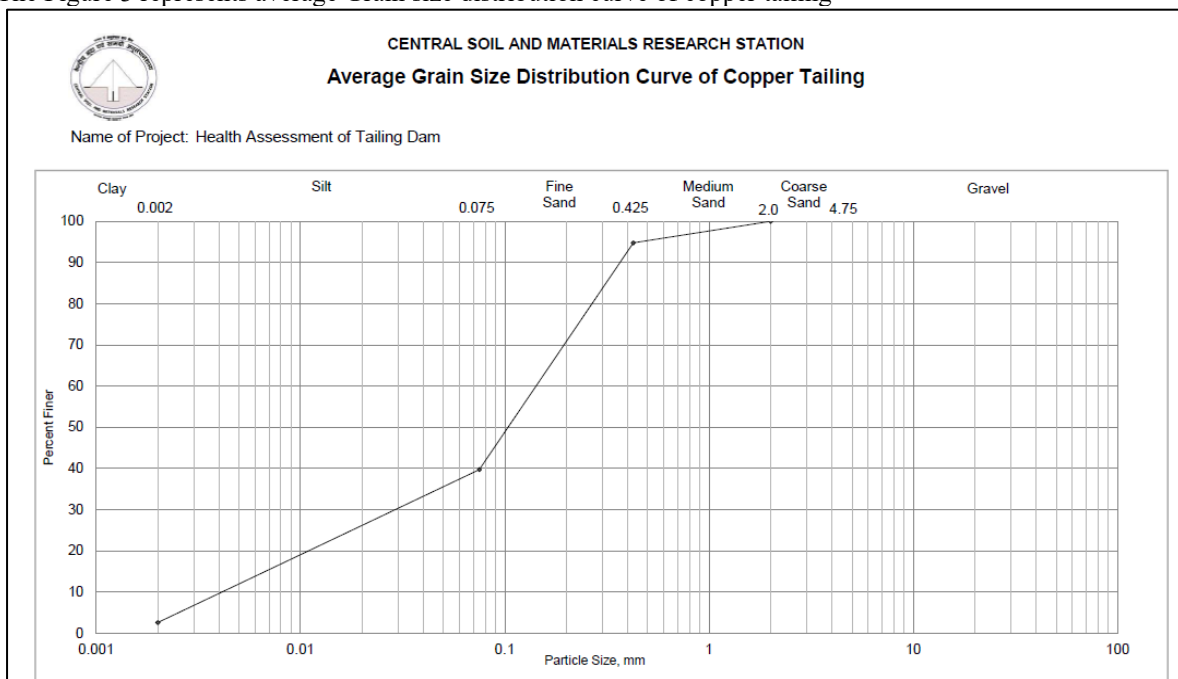
Figure 3: Average Grain size distribution curve of copper tailing

The Figure 3 represents average Grain size distribution curve of copper tailing

The grain size analysis of the borrow area materials indicate that the tested soil samples in general possess predominantly fine sand sizes followed by silt sizes and clay sizes. The Liquid Limit values of the tested soil samples indicate that the soil samples in general possess low compressibility characteristics. The plasticity index values of the tested soil samples indicate that all the 6 tested soil samples are non-plastic in nature. The values of Maximum Dry Density and Optimum Moisture Content of the tested soil samples vary from 1.97 g/cc to 2.00 g/cc and 9.2 % to 11.2 % respectively. Based on the Standard Proctor Compaction tests, it is inferred that the tested soil samples can achieve good compaction densities.

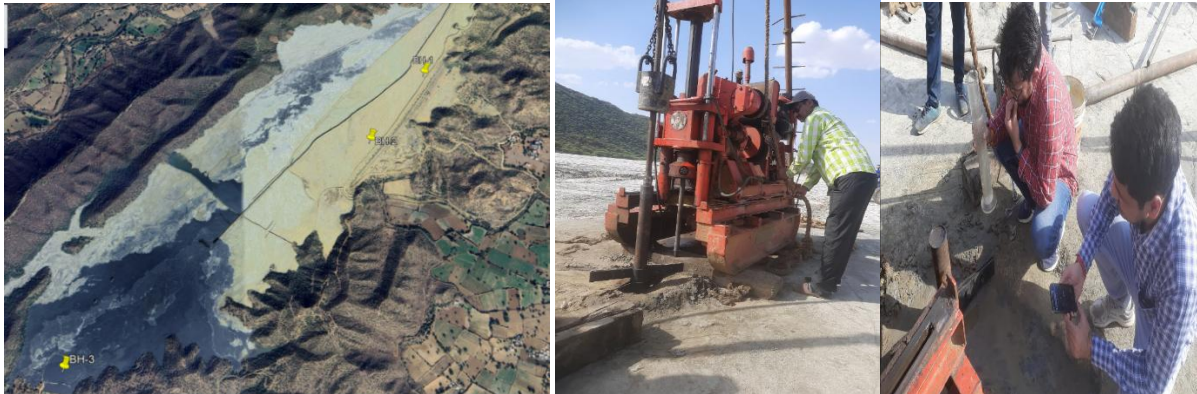
**Figure 3.** Location of 3 boreholes, SPT and field permeability test

In the present study, three bore holes of 100 mm diameter have been conducted in copper tailing mines with varying depths from 13.5 m to 20.5 m. In the bore hole SPT tests have been carried out as per IS 2131 (1981). The Figure 3 presents map for locations of 3 boreholes. The BH-1 is at 0.5 Km from BH-2 in upstream side whereas BH-3 is 1.5 km from BH-2 in downstream side.

From the Table No. 4, 5 & 6, it has been observed that at all 3 bore holes lithology presents Silty Sand (SM) and N values varies from 7 to 60.
