Impact Analysis of the Whirlwind Disaster on Residential Roof Frame Structures (Case Study in Tonro Kassi)

ABSTRACT: *Damage to buildings due to wind disasters is often found on the roof truss of a building. Thus, roof truss structure is an important part of construction. This study aimed to determine the damage to the roof truss structure due to the wind disaster in Tonrokassi village, Tamalatea district, Jeneponto Regency, the vulnerability of the building and identify the existing roof truss after the disaster. The method of classifying damage levels of structures is by using the Fujita scale. Based on the field scoring results, it can be seen that the damage is almost entirely on the roof. For the level of damage for point 1, it is only damage to the roof such as zinc being released from the frame. While the house has a damage level of 2, the roof has been damaged and part of the roof frame has been blown off.*

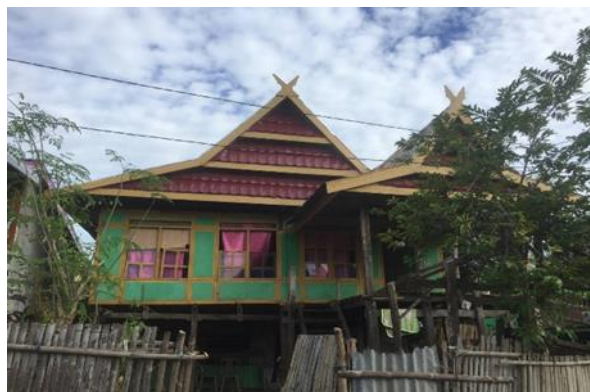
Fig 3. Outer roof view

The gable roof structure uses trusses as roof supports which are then channeled to column points which must be balanced with accurate planning and calculations [13]. If it looks from the outside, the roof model can be displayed in Figure 3.
